Chapter 9: Troubleshooting

9.1 Abnormal Conditions.

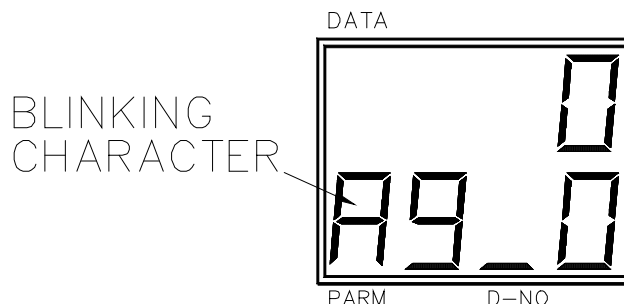
Abnormal Code 9 Sub-Code 0

When an Abnormal condition occurs (ABNORMAL LED is lit), the display mode will automatically change to the STATUS mode. (If the display is not in the STATUS mode, depress the MODE button until a blinking "A" appears in the [PARM] display area) A code number appears at the right side of the blinking character. This code refers to some specific type of failure detailed in the tables shown in the following sections.

The number shown at the most right position in the [D-NO] display area is a sub-code that can be used in conjunction with the Abnormal failure code to further narrow down the cause of the fault. See the following sections.
